COUNCIL MEETING AGENDA REQUEST FORM

- 1) **Resolution for Council to approve the Mayor to enter into contract with Associated Waterproofing Corp to Repair exterior wall and waterproof the Evidence Building in the amount of \$57,600.00.**

RE: 106 North Cherry St.
Police Annex Evidence Storage Building

Re: 106 N. Cherry St.
Structural Review

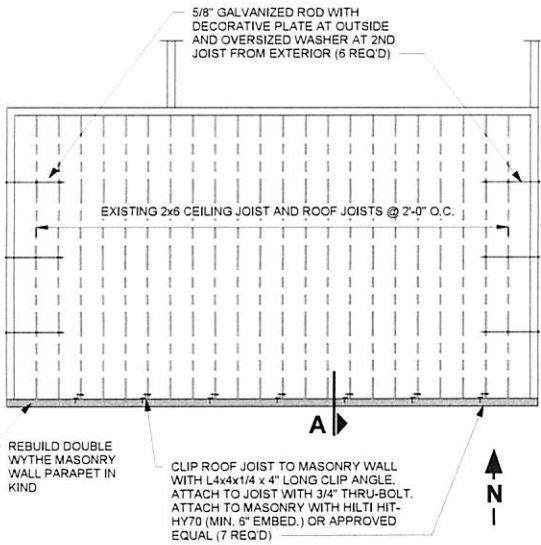
ROOF FRAMING PLAN
1/8" = 1'-0"

During a recent re-roofing project, the top portion of the east and south walls exhibited unusual movement. The roofing contractor removed the parapet on the south wall. During my visit, I was able to access the second floor ceiling space. There are 2x6 ceiling joists attached to the masonry wall with metal straps embedded into the brick but the roof rafters are not attached to the masonry walls. The roof rafters are supported by a ledger on posts that bear on the ceiling joists. Without lateral support at the roof level, the walls has apparently hinged at the bearing elevation of the ceiling joists. Consequently, that portion of the wall above the ceiling joist elevation is in danger of collapse due to a lack of proper lateral support.

This is a dangerous situation and must be repaired immediately. A 10 foot wide area adjacent to the south and east walls shall be cordoned off to prevent public access until repairs are made.

I have attached a drawing that details repairs that will properly attach the walls to the roof framing. While the west wall has not exhibited movement that I'm aware of, I've included it's lateral support on this drawing since its construction is similar to the east wall.
