Phoenix Square Pedestrian Bridge Repair

FEDERAL EMERGENCY MANAGEMENT AGENCY PROJECT WORKSHEET					
DISASTER		PROJECT NO.	PA ID NO.	DATE	CATEGORY
FEMA	4263	-	DR	-LA	HMD001C
			105-32755-00	06-06-2016	C
APPLICANT: HAMMOND			WORK COMPLETE AS OF:		
			07-06-2016 : 0 %		
Site 1 of 1					
DAMAGED FACILITY:			COUNTY: St. Tammany Tangipahoa		
Pedestrian Walkway Bridge					
LOCATION:			LATITUDE:	LONGITUDE:	
Current Version: GPS coordinates: 30.494176, -90.473720			30.494176	-90.47372	
Intersection of Phoenix Square and Mooney Avenue, Hammond, LA					
DAMAGE DESCRIPTION AND DIMENSIONS:					
Current Version:					
During the event period March 8th through April 8th, 2016, the city of Hammond (Applicant) experienced tremendous flooding as a result of torrential rain. High water saturated the earthen base under the sidewalk and bridge abutment causing the sidewalk to crack in several places. The bridge abutment with bearing bench shifted 8 inches leaving voids in the earth (visible in attached photos). Lack of base support, shifting and settling, was the cause of sidewalk and abutment failure and rupture of drain. Pedestrian Walkway Bridge was damaged as follows:

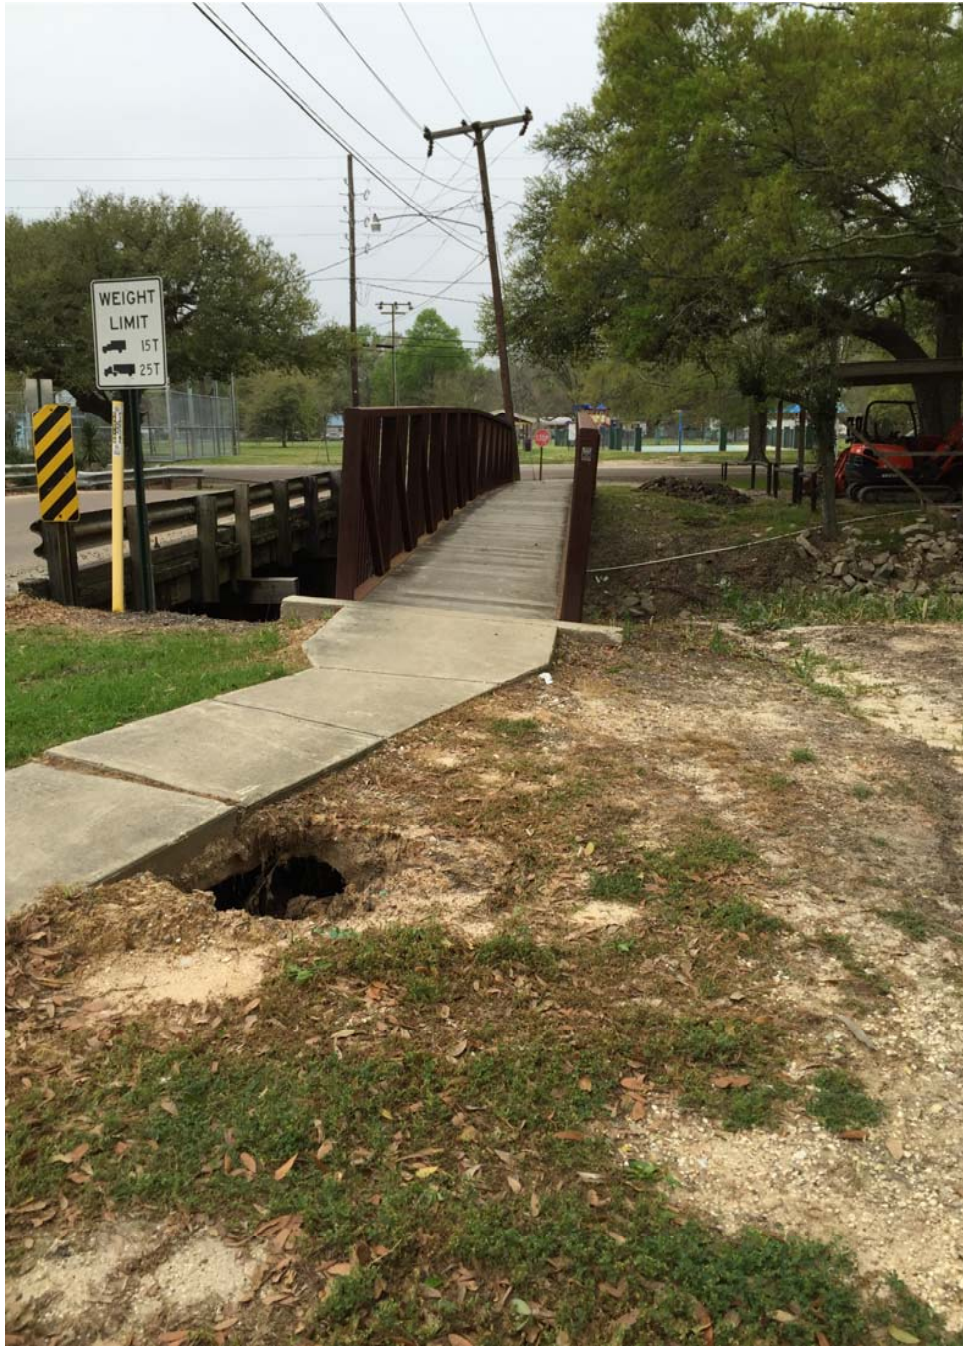
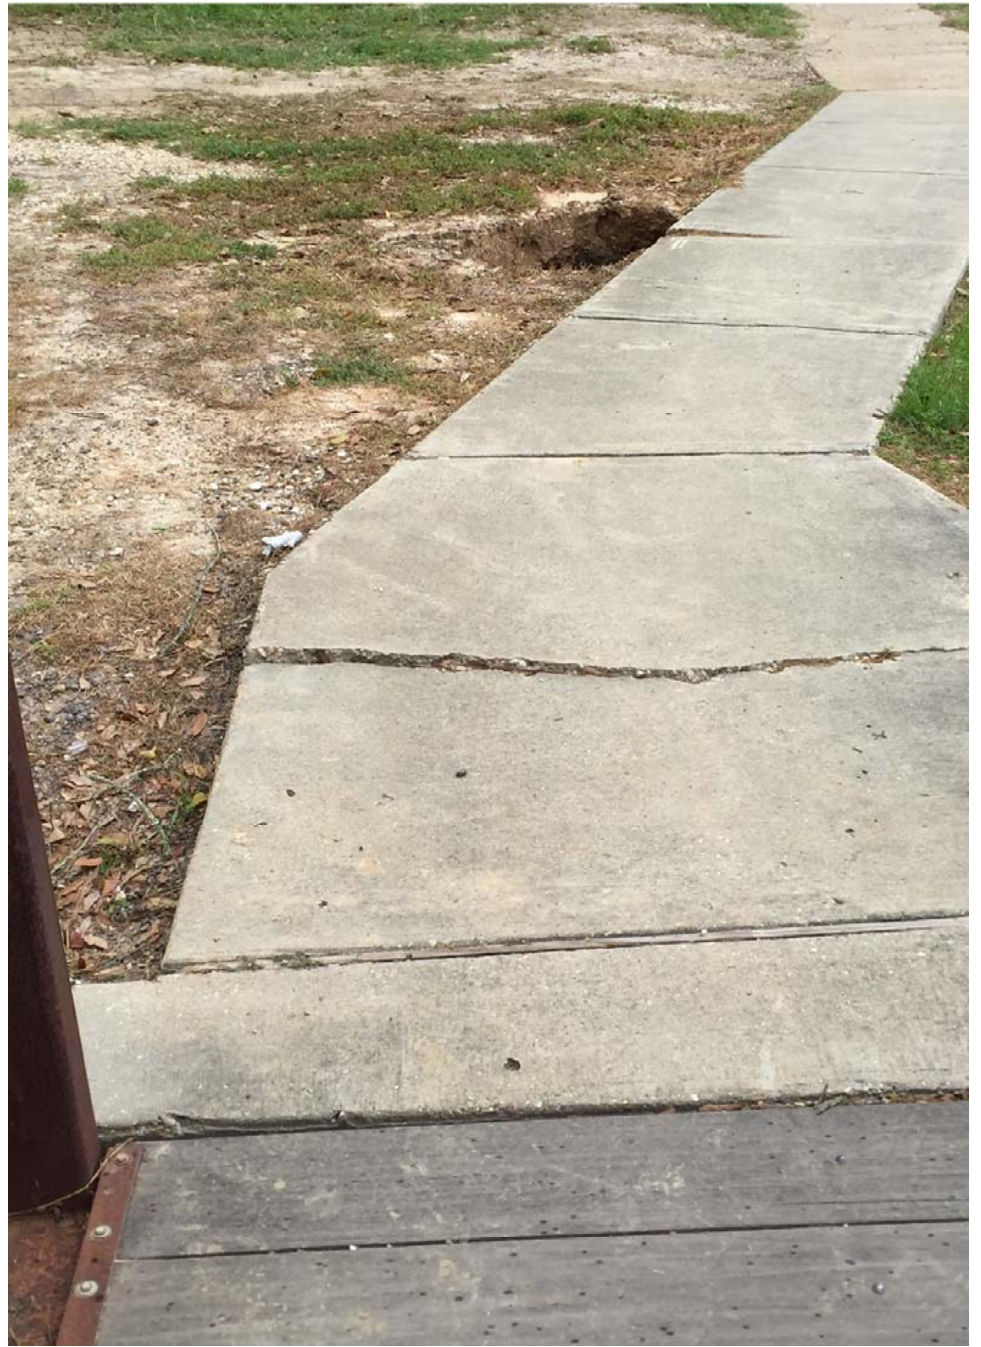
Summary Description: High water in Arnolds Creek (W2-L2) apparently saturated the east abutment of the pedestrian bridge. (See sink hole in photo). When the water subsided, a cave in occurred causing the east abutment of the bridge to settle about 8". The bridge seems intact; however, to remain ADA compliant, the following work is recommended:

1. Pedestrian Bridge 67-Ft long x 5-Ft Wide clear span bridge with 54-inch tall structural railing sits on concrete abutments at each end as shown in the attached drawing. The east end abutment is 5-feet above a 24-in CMP and slightly on the north side of the abutment. Due to excessive rains saturating the earth, washed out causing the abutment to drop 8 inches, tilting the bridge.

2. Abutment damaged (east end) as follows:					
a. Concrete base 9-Ft L x 4-Ft W x 0.5-Ft D					
b. Abutment w bearing bench = 7-Ft L x 3-Ft W x 3-Ft H + 7-Ft L x 1-Ft W x 1-Ft D

3. Sidewalk 30-ft long x 5-ft width x 4-in thick damaged					
4. CMP Culvert (Storm Drain) 24-in x 50-LF damaged					
SCOPE OF WORK:					
Current Version:					
WORK TO BE COMPLETED:					
Applicant will use contract labor to complete repairs. The following costs were estimated using historical costs provided by city engineer; FEMA cost codes and RS Means (attached) provided by FEMA Engineer Richard Graham, NEA/BVI. Notes are provided with each cost to clarify estimates:

a. The applicant will employ a contractor to move in a crane, detach the bolts holding the bridge to the abutments and lift the bridge to the side so the east side abutment can be replaced. The city's engineer estimated four 8-hour days for use of the crane considering mobilization and demob 2-times. CDH Crane Rental provided local crane rental costs. The company owner said this job would require an 80-Ton crane due to the angle of reach and distance to the middle of the 67-ft long bridge being at least a 40 to 45-ft horizontal distance. The cost is \$180.00/hr with 2.5-hrs for mobilization and setup and 2.5-hrs to demobilize leaving 3-hours use in an 8-hr day. It is estimated that the crane would be needed for 12-hrs to remove the bridge (including mob and demob time) x \$180/hr = \$2,160 x 2 (use same hrs for resetting the bridge) = \$4,320. This cost is only for the crane and operator and additional personnel and equipment would be required to prepare a pad to sit the bridge, for detaching the bridge from the abutments and rigging of the bridge for lifting by the crane. The \$10,000 for both the bridge removal and another \$10,000 for replacing the bridge would cover this cost and is considered reasonable.

2. Abutment repaired by the following process:

a. Abutment Base: break up and haul concrete base 9-Ft L x 4-Ft W x 0.5-Ft D/27 = 0.67 CY

b. Abutment bearing bench: break up and haul 7-Ft L x 3-Ft W x 3-Ft H = 2.33 CY + 7-Ft L x 1-Ft W x 1-Ft D /27 = 0.26 CY; Total = 2.6 CY
a and b: Cost of Abutment Removal: (CC4050 for CONCRETE REMOVAL, REINFORCED includes breakup and hauling) 0.67 CY + 2.6 CY x \$140.00 CY = \$457.80

c. Abutment replaced: The cost to pour the new abutment will be 3.27 CY (see attached drawing) x \$1,000/CY (local bid costs) = \$3,270. (Note, TVA's cost code 3215 at \$607.50/CY includes high-strength concrete, building forms and form removal. The engineer used \$6,000.00. Since the Local Bid Cost already includes forming, casting and form removal, it seems the \$3,270 would cover the necessary cost since material cost for concrete is only about \$100/CY).
Abutment Concrete and construction - \$3,270.00

4. CMP Culvert (Storm Drain) 24-in x 50-LF repaired as follows:

a. The storm drain 24-in CMP culvert will be excavated 75-CY estimated by the city engineer with dimensions averaging 50-ft long x 5.8-ft wide x 7-ft deep / 27 = 75 CY of earth material to be excavated, removed and hauled to the city/county stockpile. The excavation cost is estimated using CC 4021 at \$16.63 for removal only x 75-CY = \$1,247.25. An 18 CY dump truck would be needed for 8-hrs (75-CY / 18-CY = 4.2 loads) to haul the excavated material to the city/county stockpile using cost code 8723 (18-CY dump) at \$77.25/hr x 8-hrs = \$618.00. Dump Truck operator using RS Means General Labor Cost is \$61.87/hr (includes O&P) x 8-hrs = \$494.96.
Cost for Excavation of storm drain = (\$1,247.25 + \$618.00 + \$494.96) = \$2,360.21

b. The new 24-in x 50-ft CMP using cost code 3354 at \$60.00/LF x 50-ft = \$3,000 which includes the culvert, bedding and backfill up to 5-ft deep. Additional fill of 2-ft deep x 50-ft long x 5-ft wide / 27 = 18.5 CY of compactable fill x \$20.00/CY = \$370.00 (local in place cost of \$20.00/CY per the engineer). A storm drain catch basin will be required which will be a 4-ft x 4-ft x 4-ft concrete box with a steel grate at the surface for drainage. This catch basin, which the engineer estimated to be \$1,900.00, is for connecting the undamaged 28-in CMP to the new culvert.
